*Thermal Stability of Al₂O₃ Coatings
Deposited on
Si and High Performance Materials*

J. D. Meyer

Department of Chemical, Biochemical, and Materials Engineering
Stevens Institute of Technology

February 9, 2000

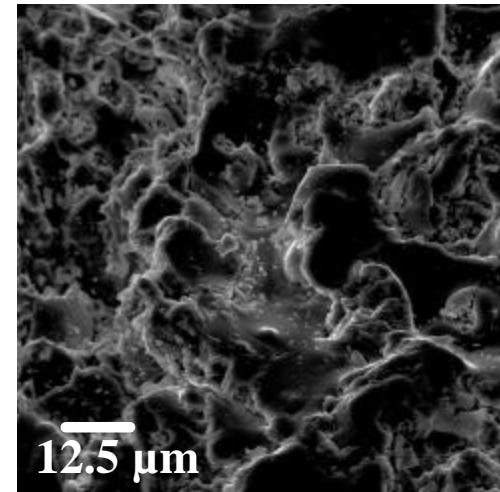
Surface morphology
of APS-CSZ
(as received)

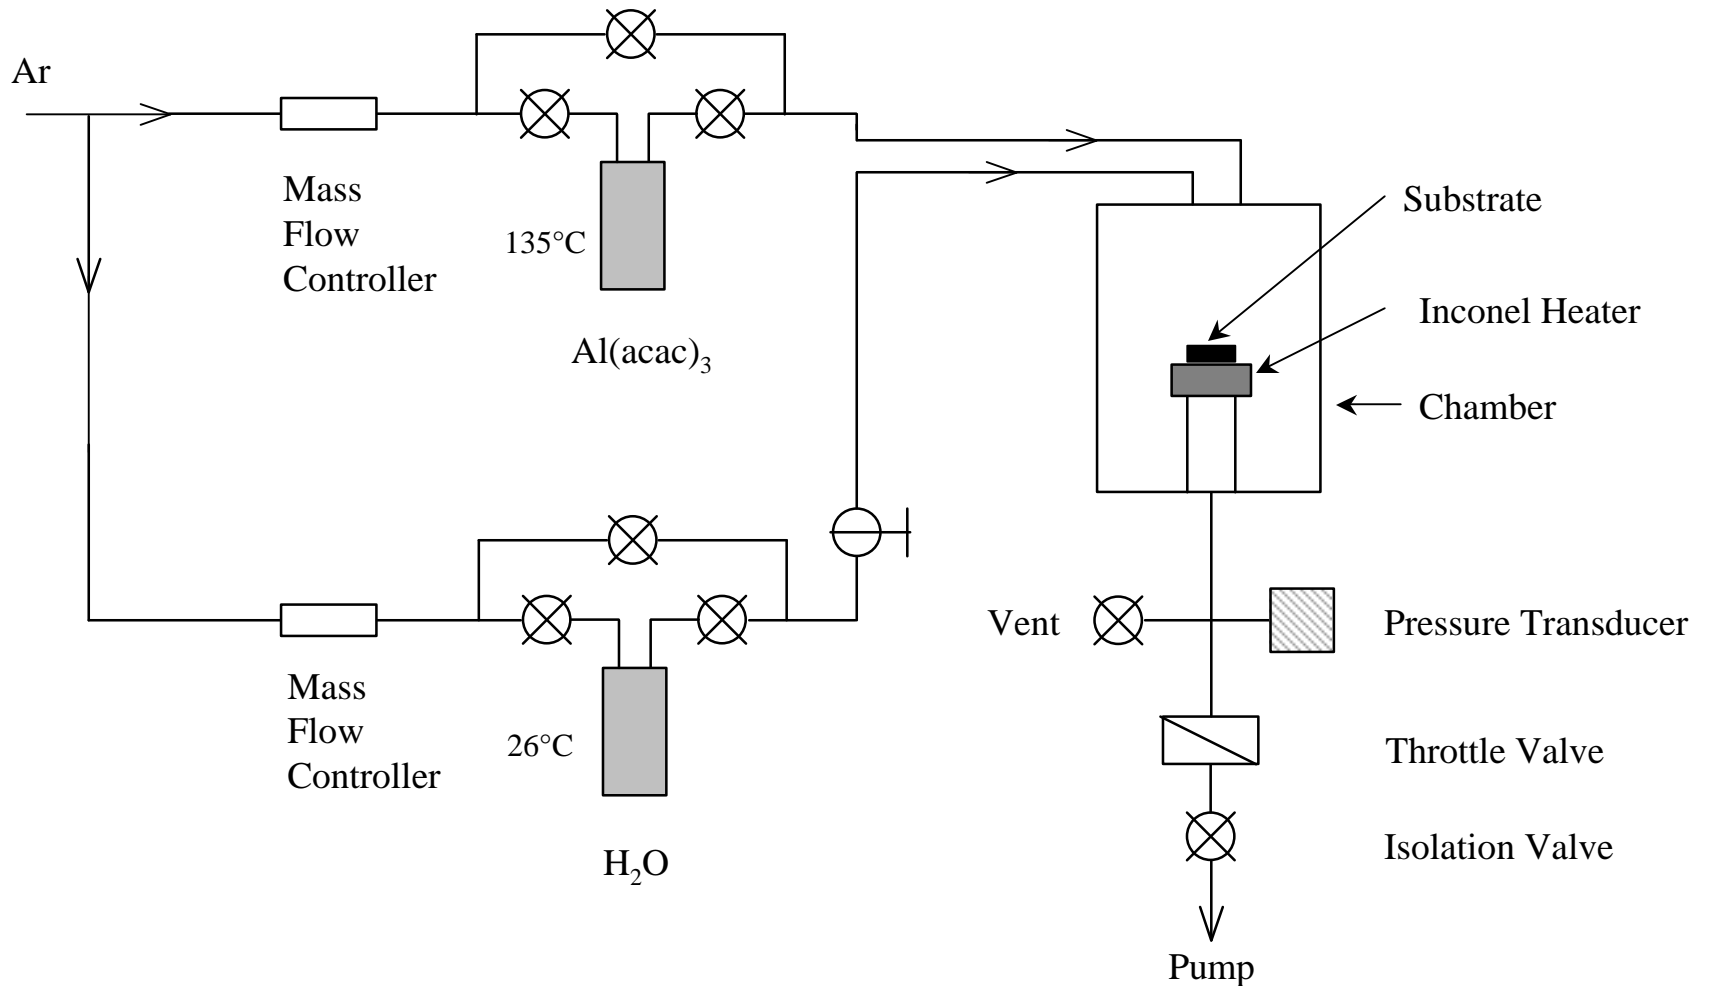
Cold-wall Al_2O_3 MOCVD System Constructed

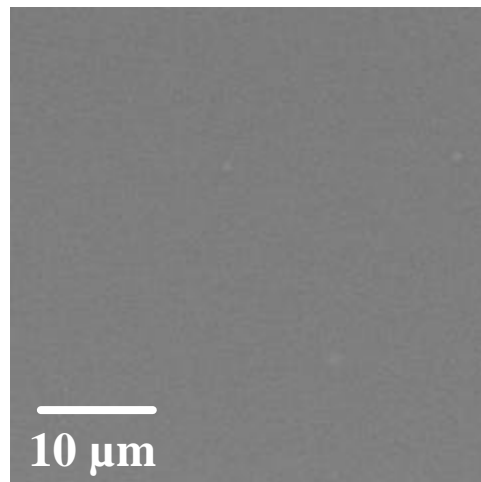
Al₂O₃ on Si

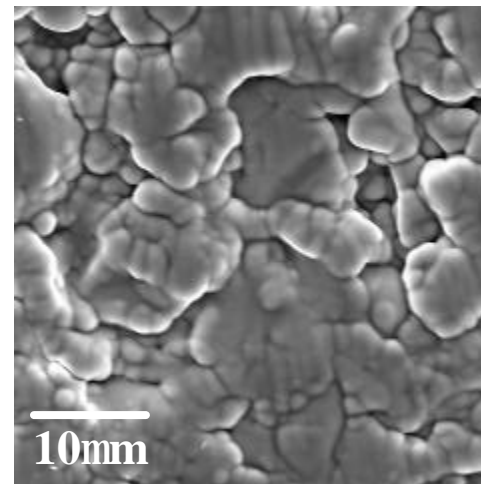
Al₂O₃ on CSZ

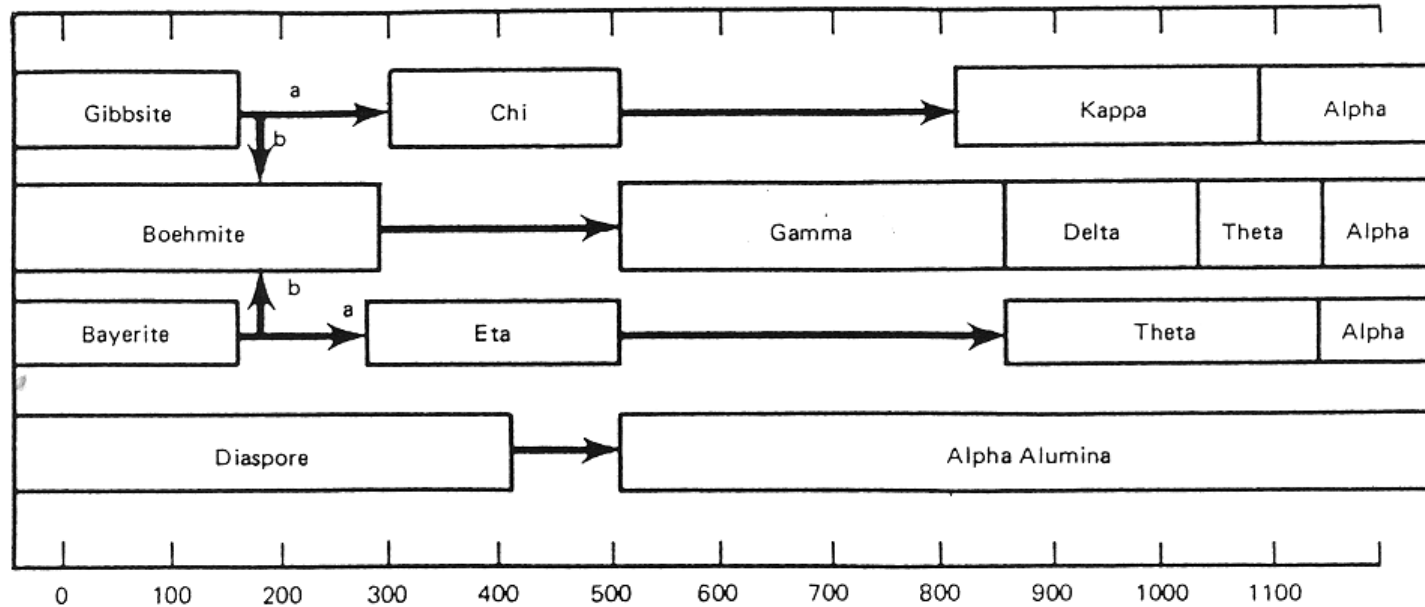
Figure 1. Transformation series of different aluminium hydroxides and aluminium oxide hydroxides in air (Temperature in °C). Open area indicates range of transition. Path b is favoured by moisture, alkalinity and coarse particle size (100 μm), path a by fine crystal size (below 10 μm). Reprinted from Reference [1] (p. 17) with the permission of The American Ceramic Society.

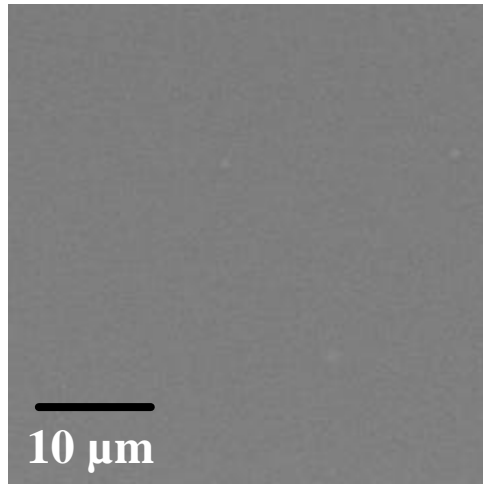
Thick (2.25 μm) Al_2O_3 on Si Spalled upon Annealing

As coated

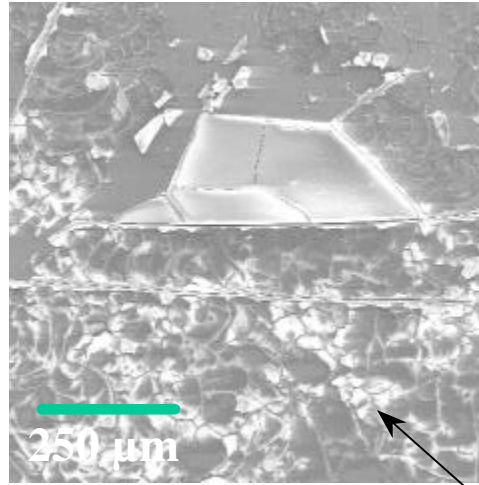
800°C

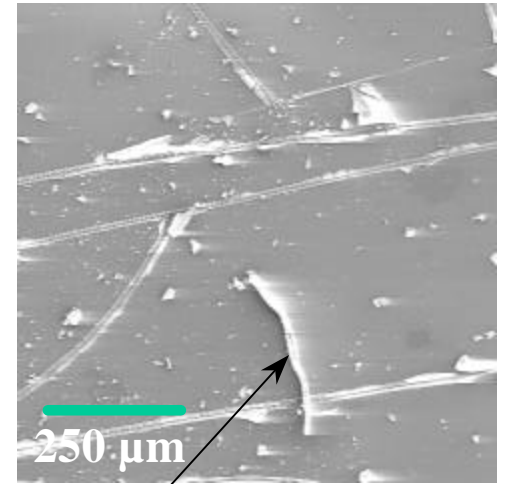
900°C

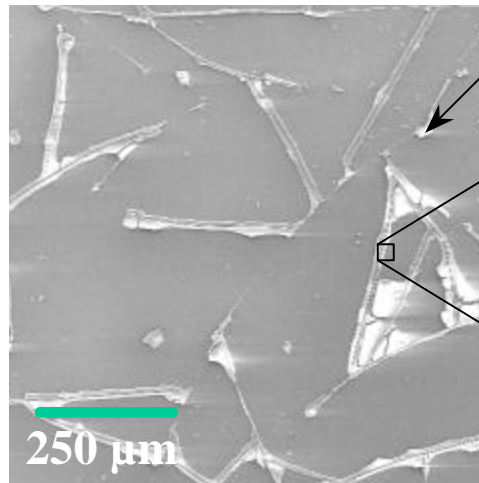
1200°C

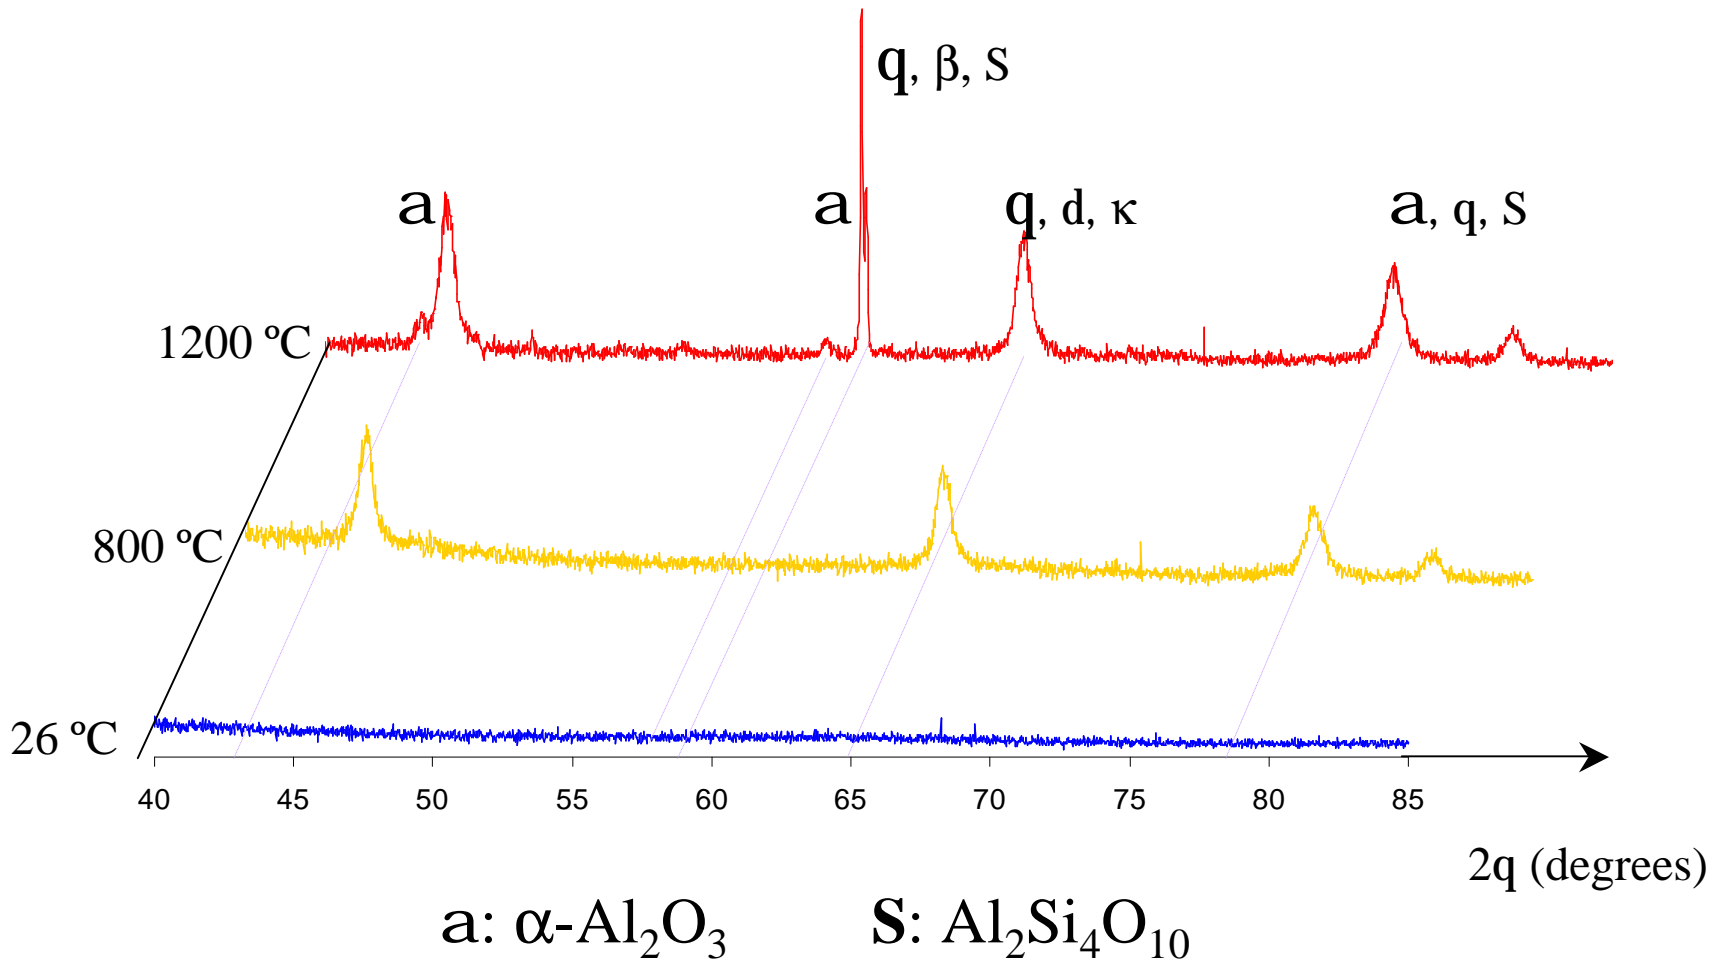
Crystallization of MOCVD Al_2O_3 Occurs Relatively Rapidly (20 Hours) at 700°C to 1200°C

Not much Al_2O_3 remained on the substrate for XRD analysis

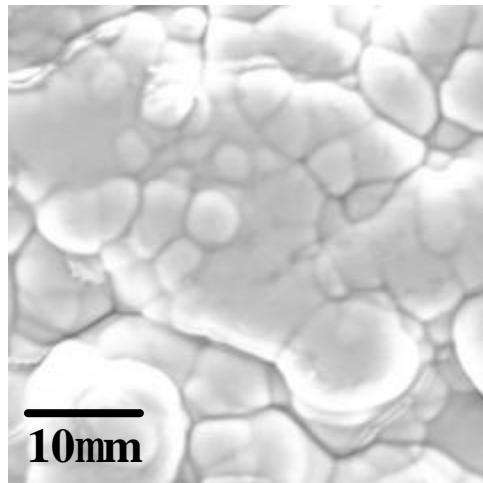
MOCVD Al₂O₃ on Un/Constrained CSZ/Iron Cracked Upon Annealing

As coated.

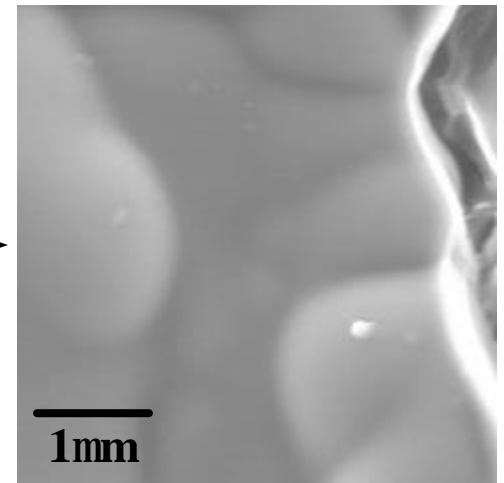
900°C

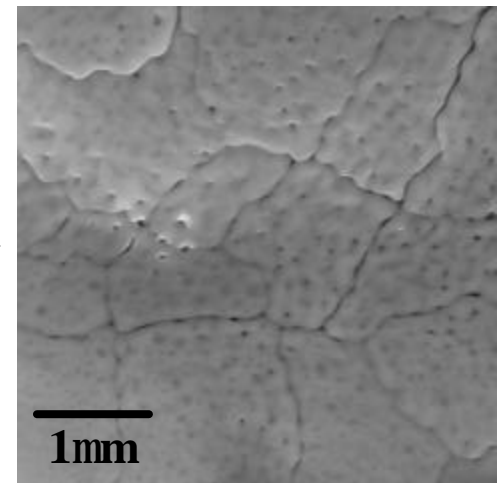
1100°C

- Annealing of thick (2.25 μm) MOCVD Al₂O₃ coatings leads to inadequate adhesion and sealing
 - CTE mismatch
 - Volume shrinkage due to crystallization (~9%) (θ - \rightarrow α - Al₂O₃)
- Work by F.F. Lange stipulates that thin coatings (~100nm) are better able to contain tensile stress systems
 - crack propagation occurs only when free energy of any film would be reduced; strain energy depends on film thickness
 - There is a critical film thickness associated with a maximum internal energy

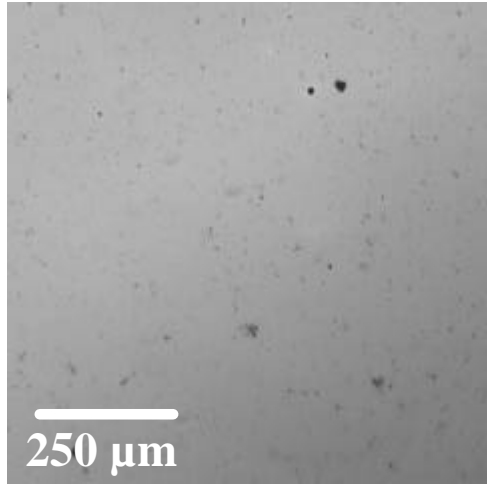
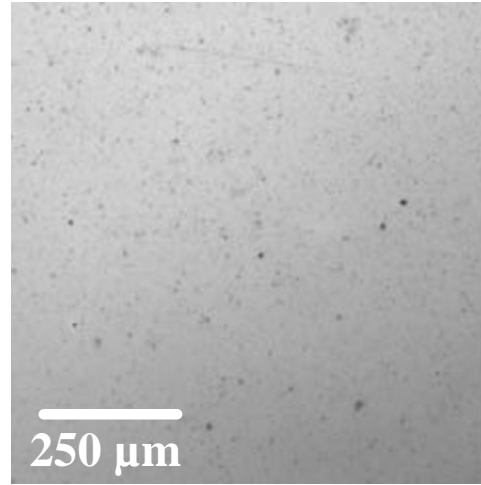
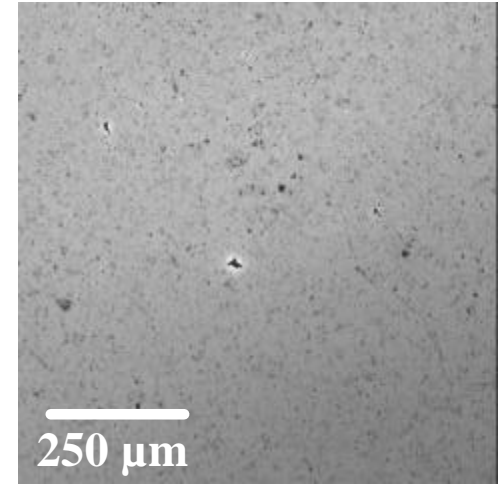
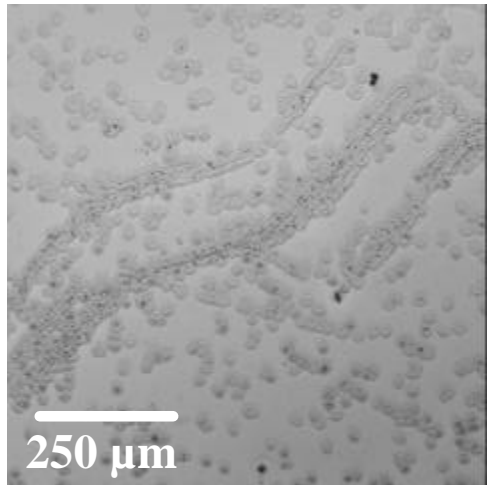
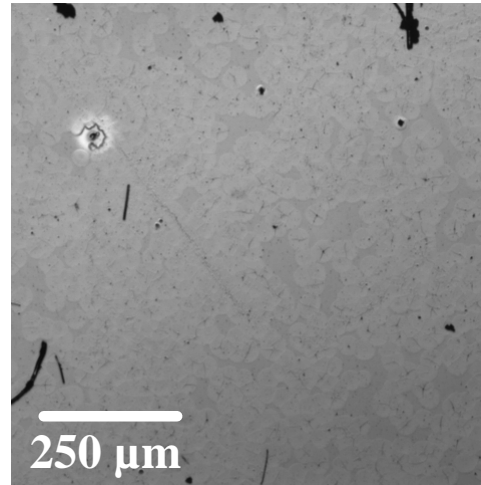
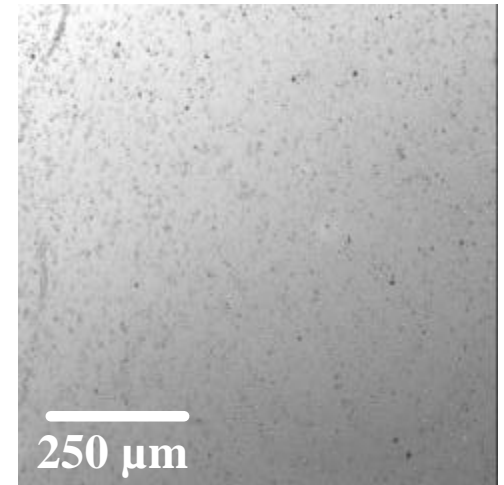
Sub-micron Coatings Exhibited Slight Cracking

290 nm

260 nm

160 nm

700°C

1100°C

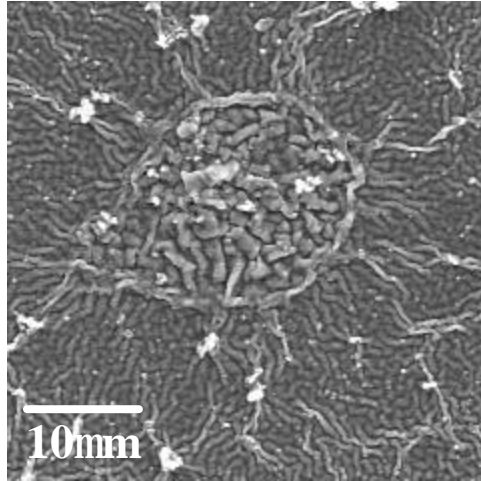
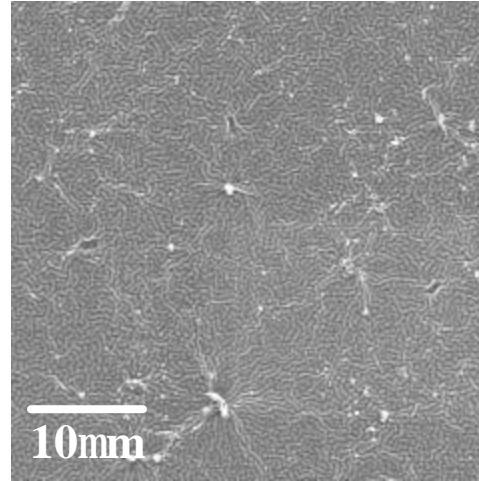
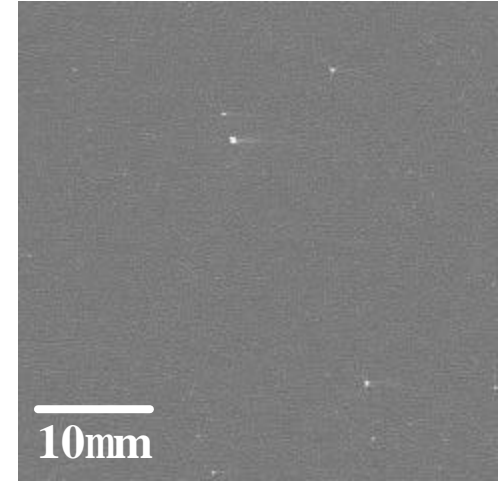
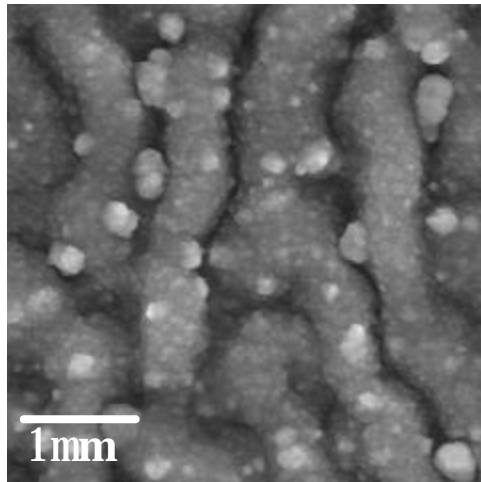
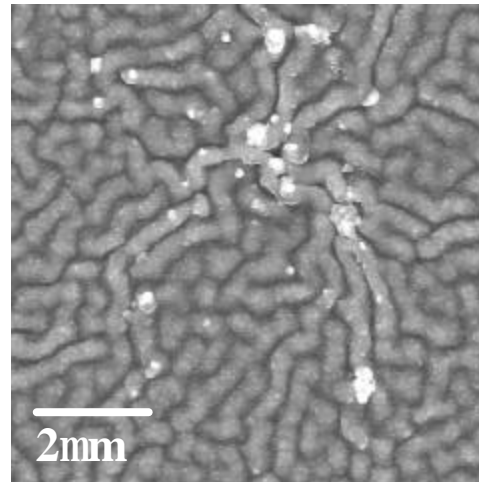
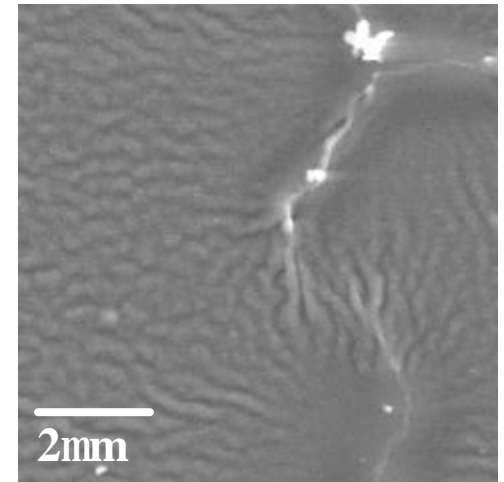
Annealing of Very Thin Coatings on Silicon Resulted in Roughening of Surface

110 nm

70 nm

40 nm

- Thinner coatings on silicon appear to maintain a lower distribution of crack-initiating “pores”
- Despite this, transformation is not evident in XRD patterns, requiring additional effort to confirm Al₂O₃ crystallization
- Sub-100nm coatings may provide a solution to the micro-cracking problem, but are they sufficiently conformal?
- Coatings on silicon carbide appear to “coagulate” more easily as thickness drops, especially in center of samples
- Coatings on nickel alloy substrates demonstrate increased leveling as thickness decreases (by Δ of focus depth)

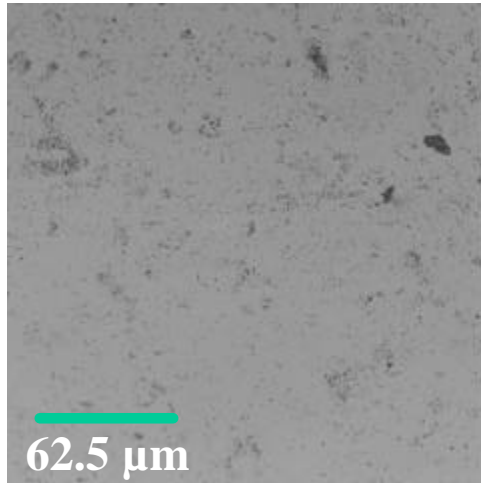
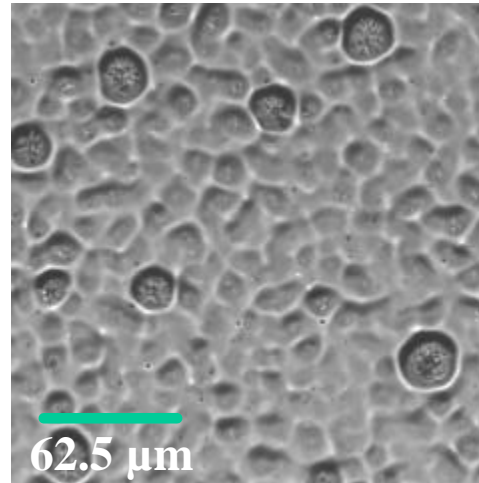
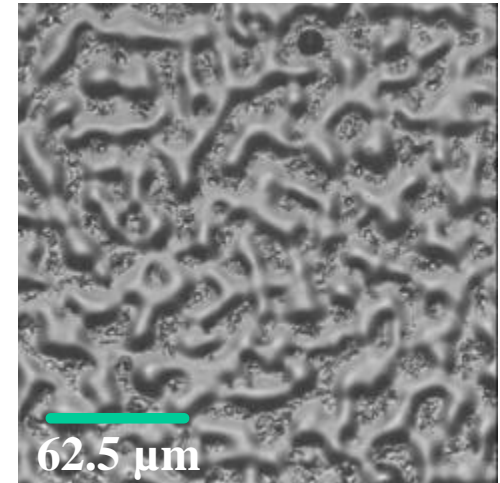
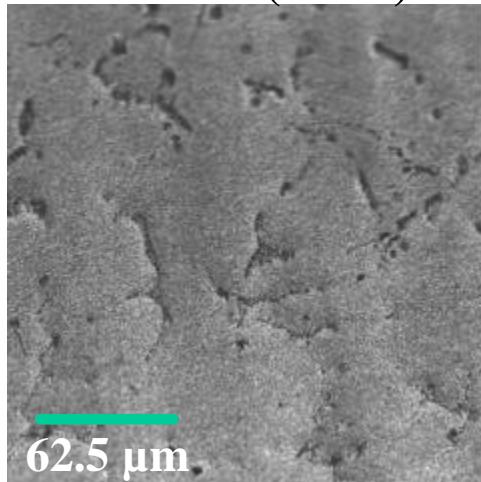
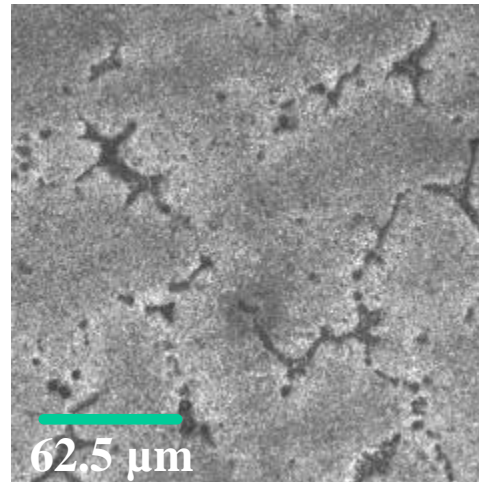
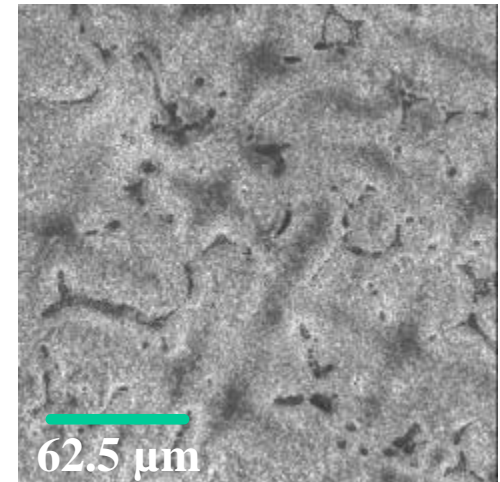
Silicon Carbide & Nickel Alloy Substrates at 1100°C

SiC

770 nm (26°C)

830 nm

510 nm

760 nm (26°C)

960 nm

540 nm

Ni alloy

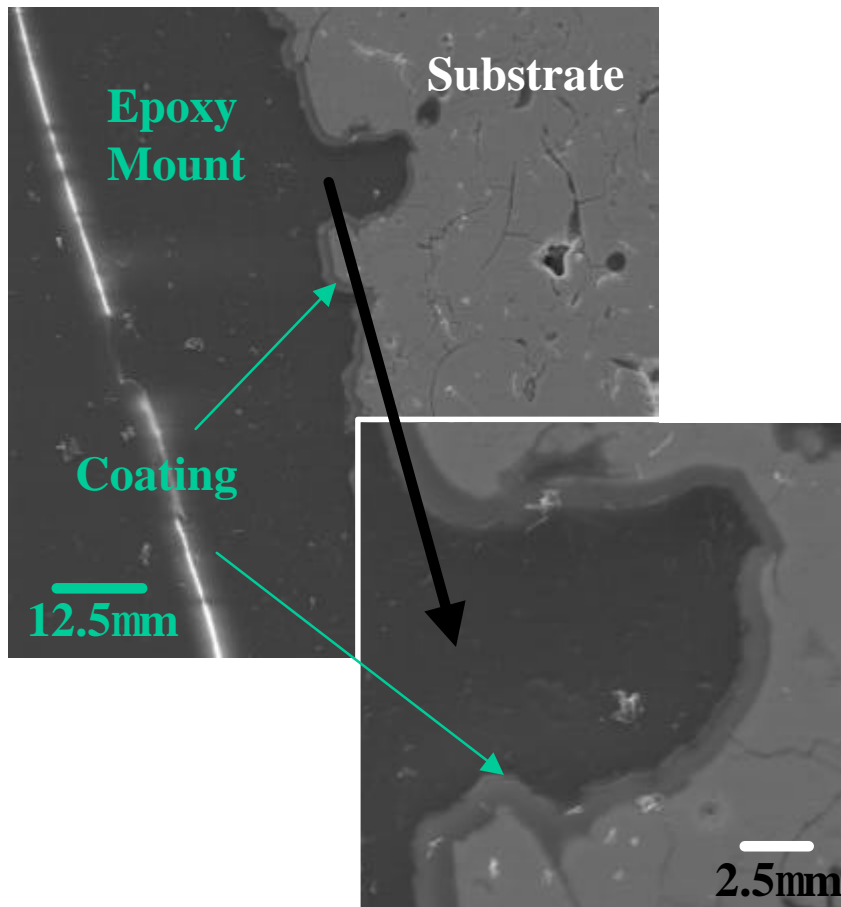
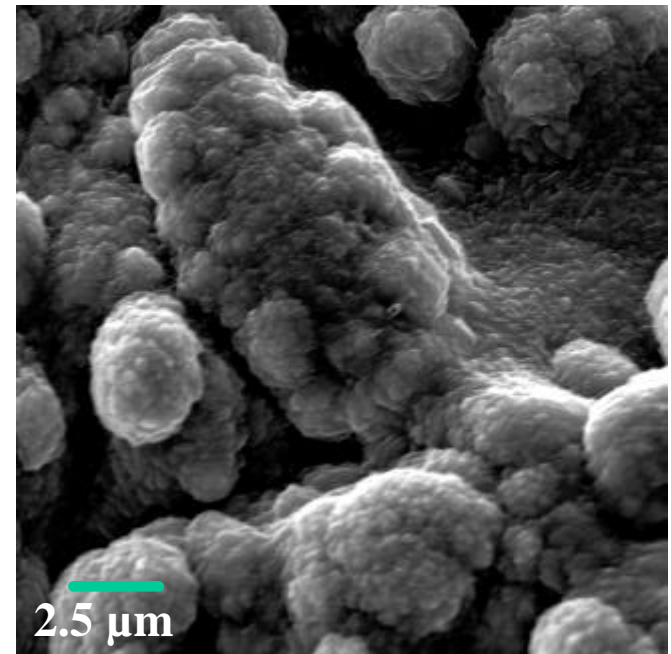
Al₂O₃ Seal Coating (from Chloride Process) Was Uniform and Conformal

As coated

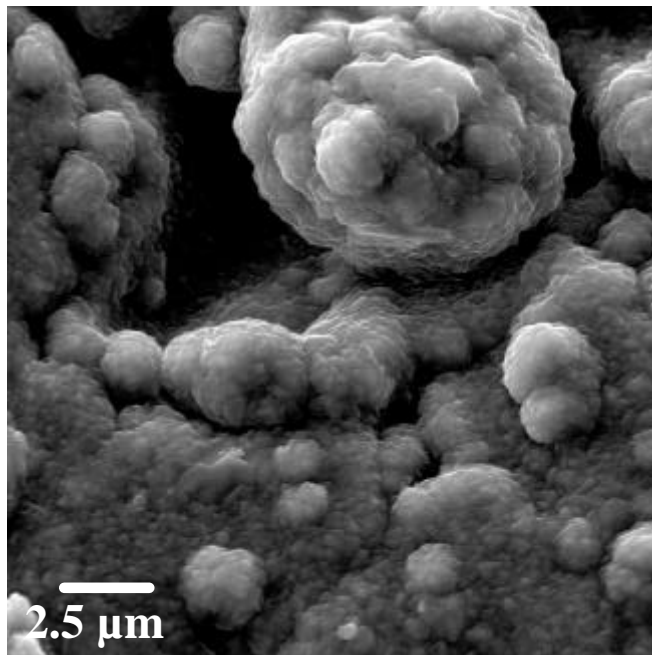
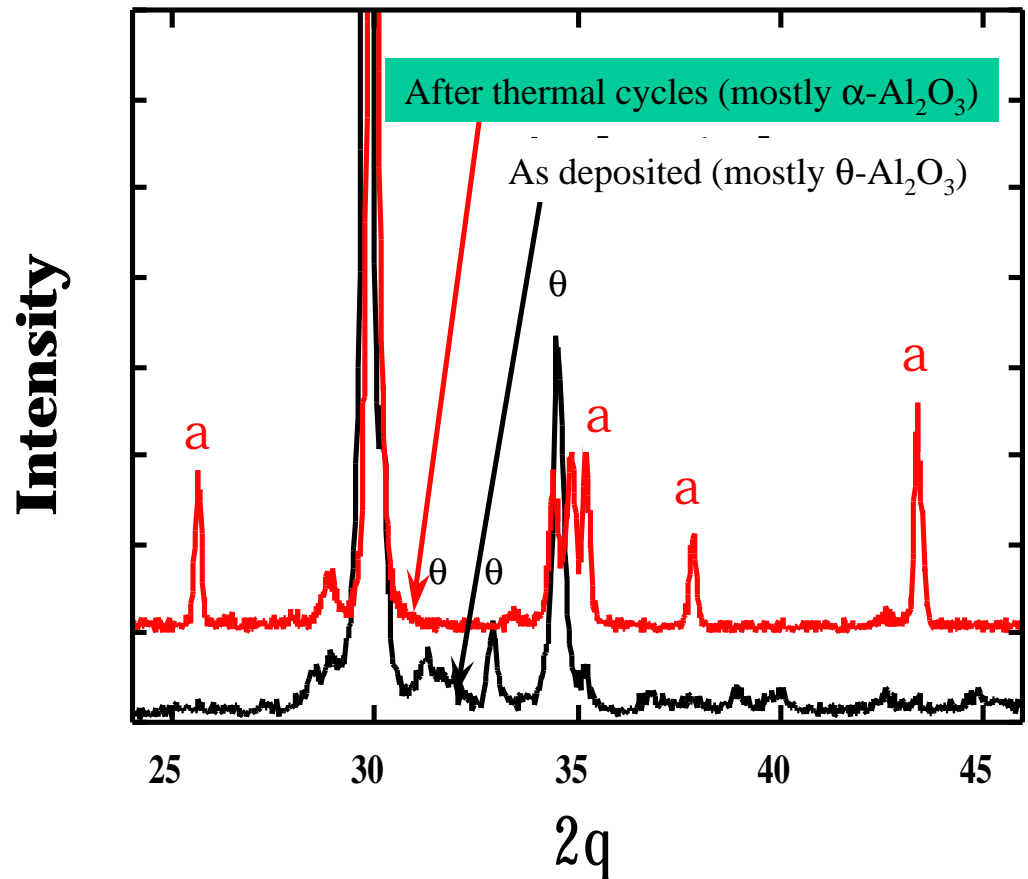
Al₂O₃ Seal Coating (from Chloride Process) Was Stable upon Thermal Cycling

After 49 1-hr. Cycles
to 1150°C

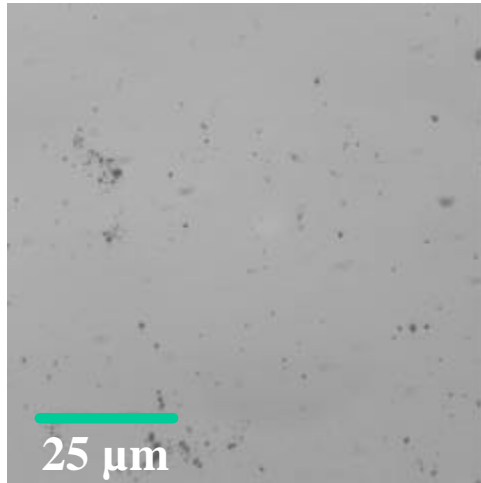
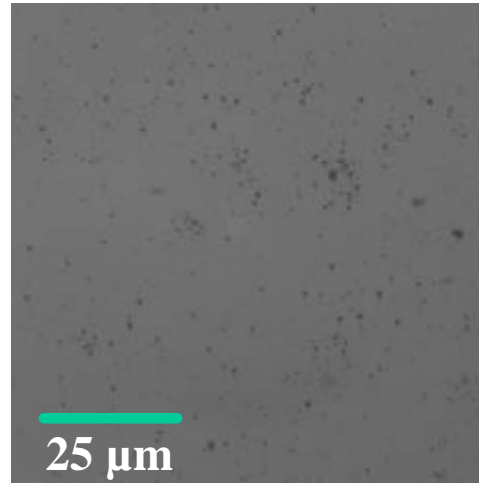
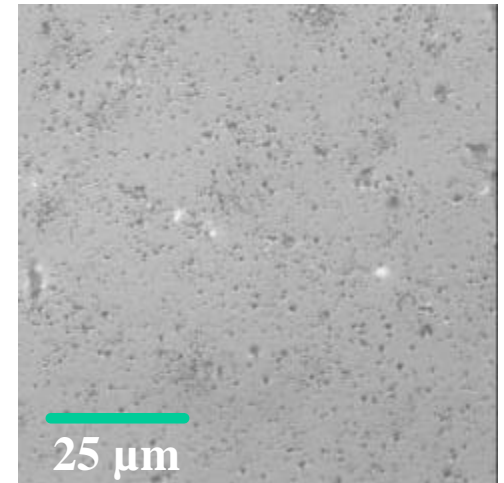
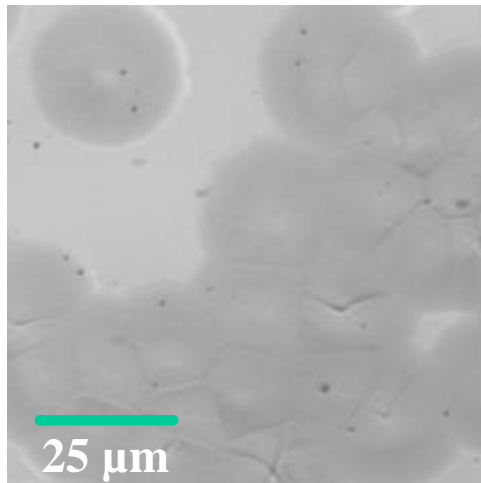
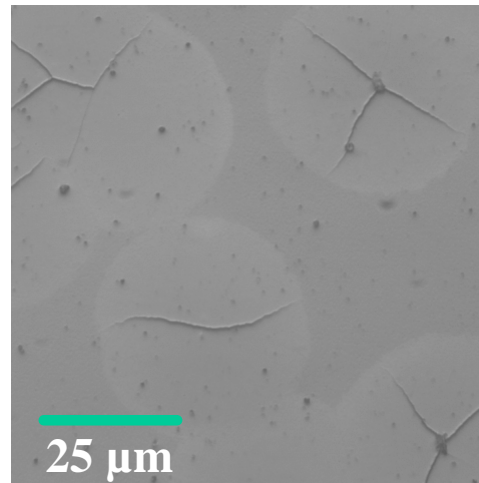
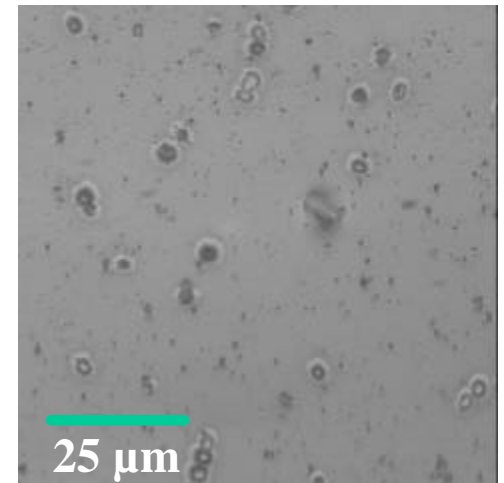
Micro-Cracking Falls With Coating Thickness

290 nm

260 nm

160 nm

700°C

1100°C

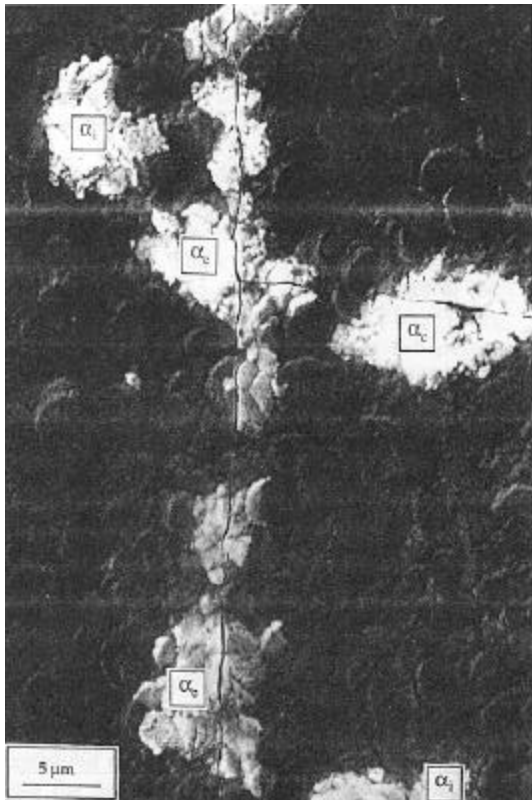
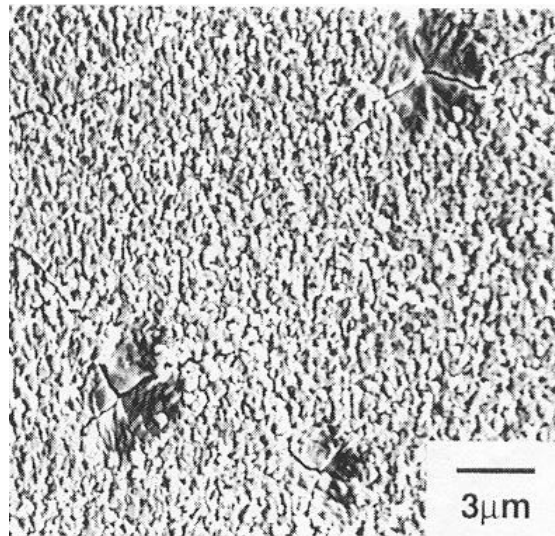
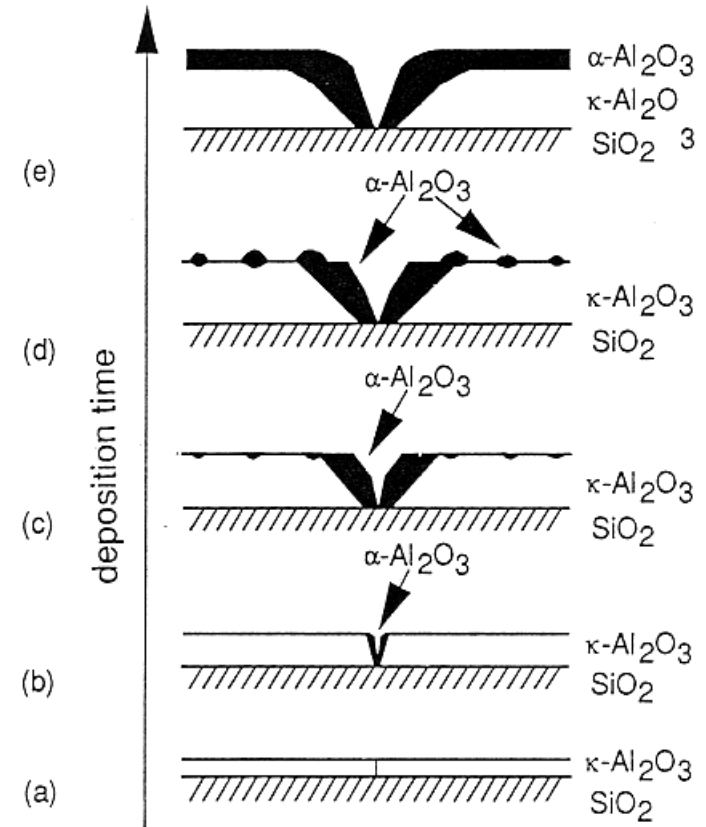
Primary Phase Nucleation Mechanisms

- Surface of substrate, leading to a “rising front” as phase boundary migrates upwards
- Grain boundary nodes
- Coating crack edges
